**INSTRUMENTATION APPENDIX TO  
PERIODIC INSPECTION REPORT NO. 5  
KNIGHTVILLE DAM, MASSACHUSETTS**

**Haley & Aldrich, Inc.  
Cambridge, Massachusetts**

**File No. 11163-006  
July 1995**

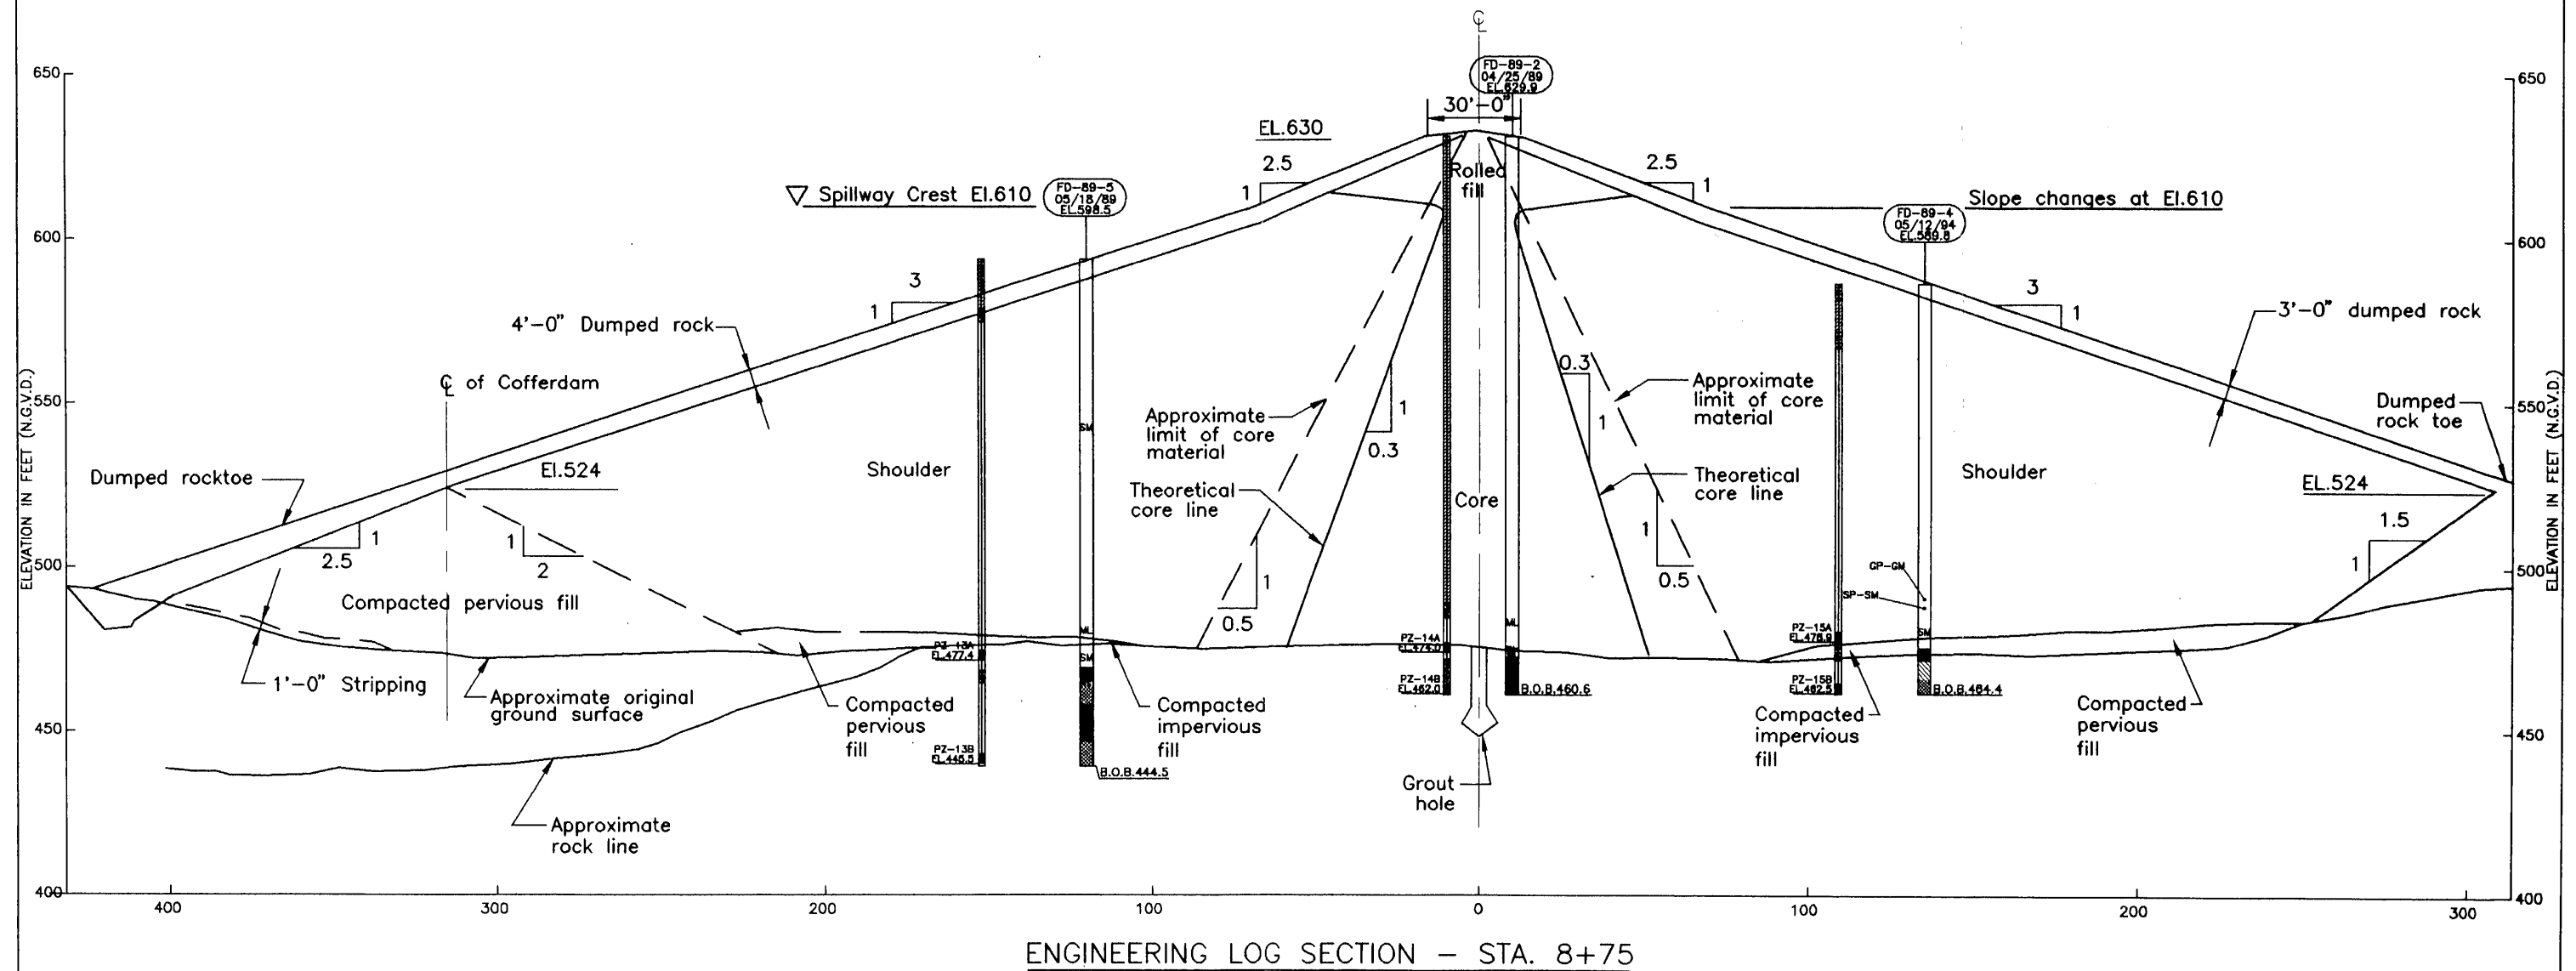
FIGURE 10

(9) PZ-14A PZ-14A is located at Sta. 8+40 and is offset 10 ft. downstream from the dam centerline as shown in the cross section drawn at Sta. 8+75, as shown in Figure 10. The top of the riser pipe is at El. 629.9. The piezometer tip is located at El. 474.0 in the foundation soil at the base of the impervious core fill. PZ-14A was installed in 1989 with a wick of filter sand which extends upward 11 ft. from El. 474 to a bentonite seal. The material influencing the piezometer tip is a medium brown silty SAND and GRAVEL.

(10) PZ-14B PZ-14B is located at Sta. 8+40 and is offset 10 ft. downstream from the dam centerline as shown in Figure 10. The top of the riser pipe is at El. 629.9. The piezometer tip is located in the foundation rock at El. 462.0. PZ-14B was installed in 1989 with a wick of filter sand which extends upward 2 ft. from El. 462.0 to a bentonite seal. The material influencing the piezometer tip is bedrock.

(11) PZ-15A PZ-15A is located at Sta. 8+75 and is offset 135 ft. downstream from the dam centerline as shown in Figure 10. The top of the riser pipe is at El. 589.8. The piezometer tip is located at El. 478.9 in or very close to the pervious horizontal drainage layer at the base of the downstream slope. PZ-15A was installed in 1989 with a wick of filter sand which extends upward

(12) PZ-15B PZ-15B is located at Sta. 8+75 and is offset 135 ft. downstream from the dam centerline as shown in Figure 10. The top of the riser pipe is at El. 589.8. The piezometer tip is located in the foundation rock at El. 462.5, just below the pervious horizontal drainage layer. PZ-15B was installed in 1989 with a wick of filter sand which extends upward 10 ft. from El. 462.5 to a bentonite seal.

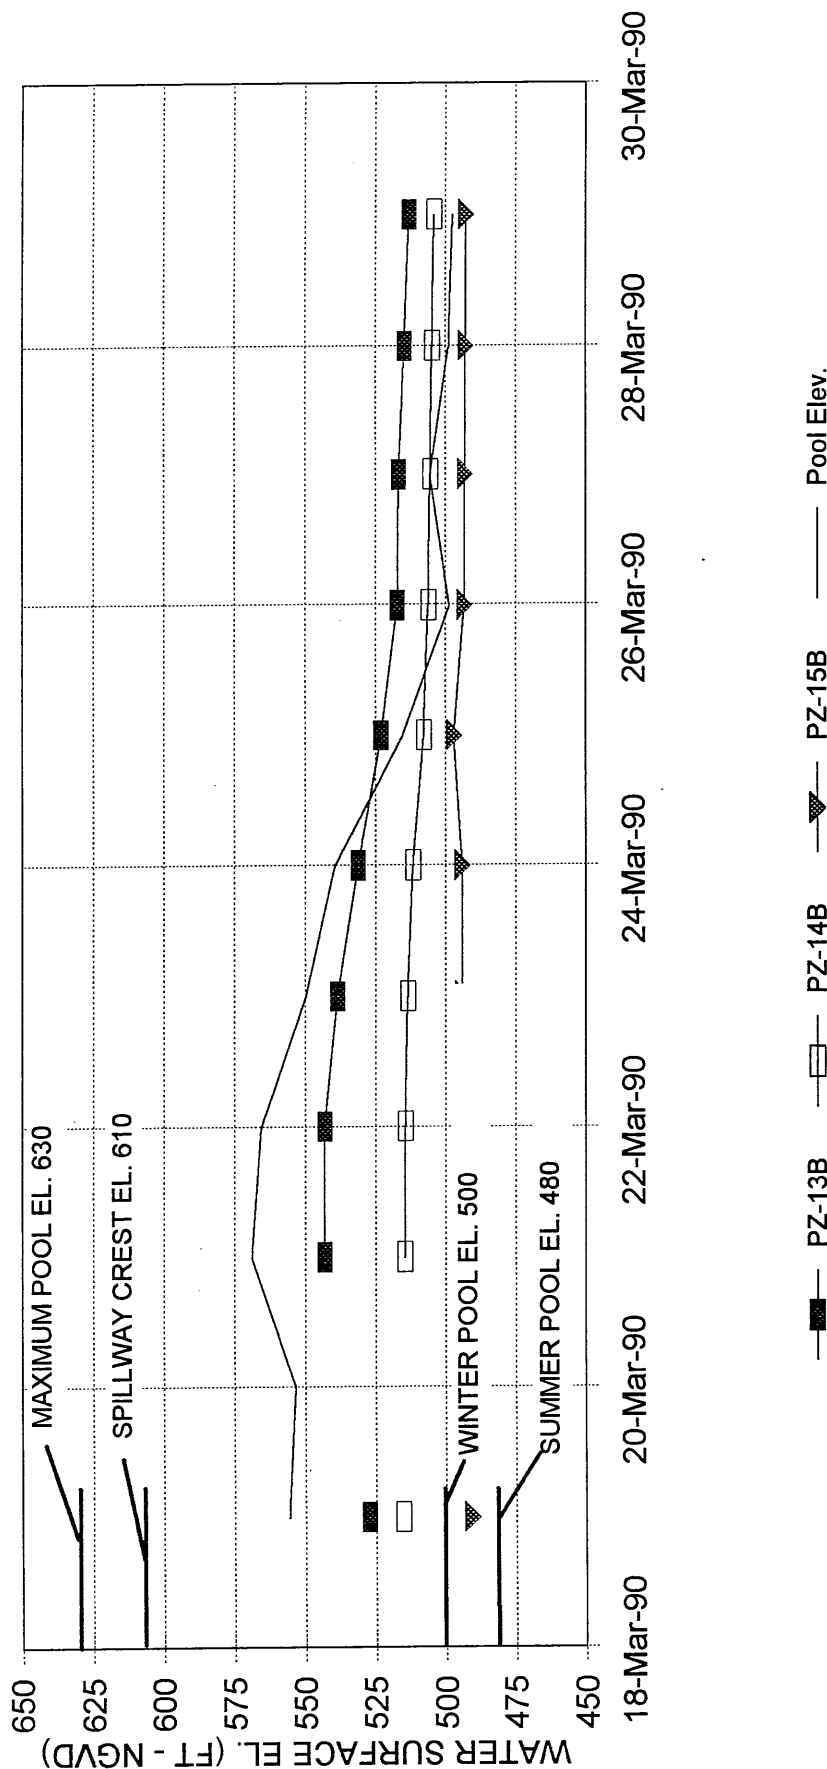
**FIGURE 19**

Based on the limited data available, the piezometer did respond to changes in pool elevation as shown in Figure 19. Water level measurements at Knightville Dam were taken at irregular intervals from March 1990 through November 1994. There were up to year-long periods where water level measurements were not obtained. However, for major changes in the pool level, such as the flood event of March 1990, daily readings are available and are shown on the event plot, Figure 26.

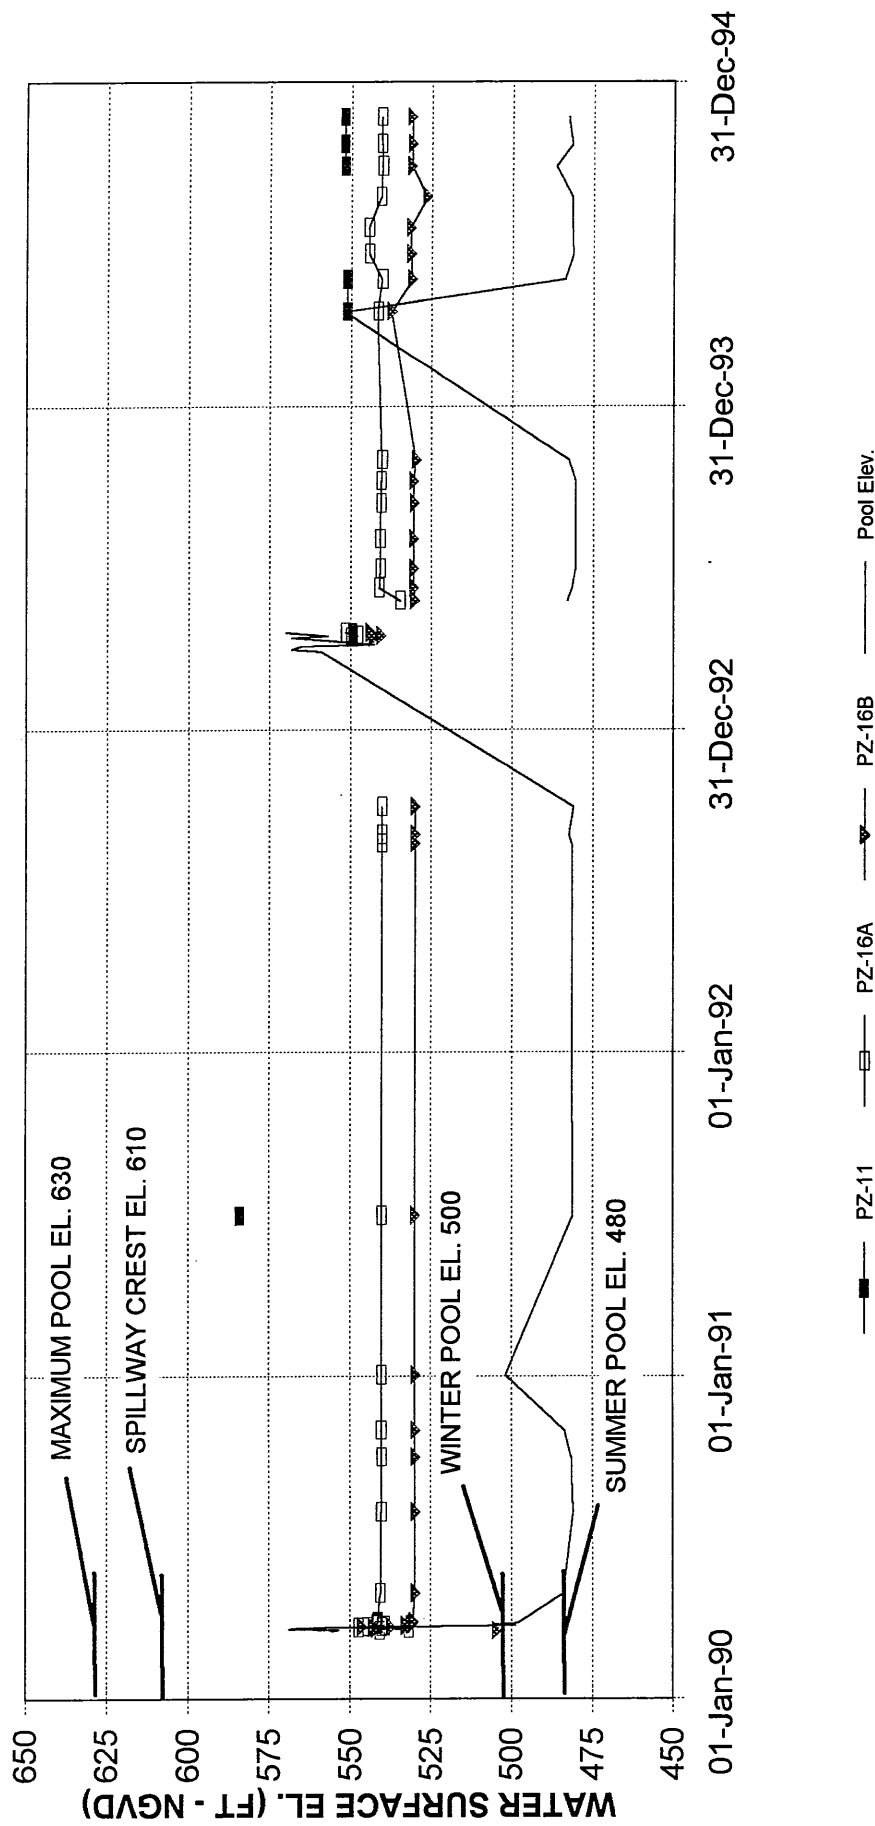
FIGURE 27

Although piezometric levels were higher than pool levels, PZ-16A and PZ-16B generally responded to changes in pool elevation that exceed the normal "background" levels for each individual piezometer. For example, at the peak pool level measured during the March 1990 flood event shown in Figure 27 (pool level 28 to 30 ft. higher than background piezometric levels), PZ-16A and PZ-16B rose about 1 ft.

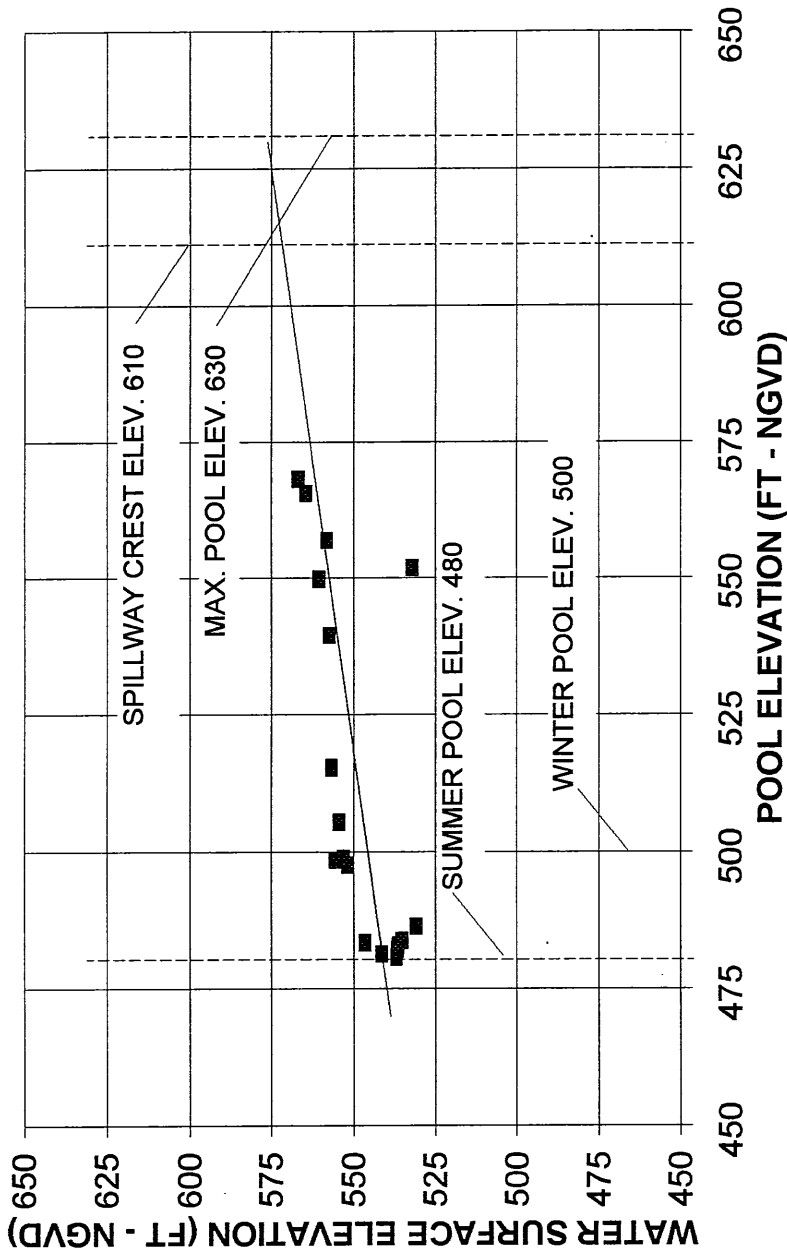
# PZ-4

Two of the original piezometers, PZ-4 and PZ-11, may not be accurate. For example, PZ-11 is typically dry independent of the pool elevation while PZ-4 is either dry or registers exceptionally high levels. Falling head permeability tests performed during a site visit conducted on 9 June 1995 indicated that the piezometer tips are probably plugged. This conclusion should be verified and if the piezometers are determined to be faulty, they should be abandoned and replaced with piezometers similar to those installed in 1989. These piezometers appeared to be functioning properly when the previous Instrumentation Appendix was published in 1989.
